Manhole Inspection Summary

Manhole # S07II2017MH

Location Address: **6301 FAIRLANE DR** Cross Street: **LARRYVALE RD**

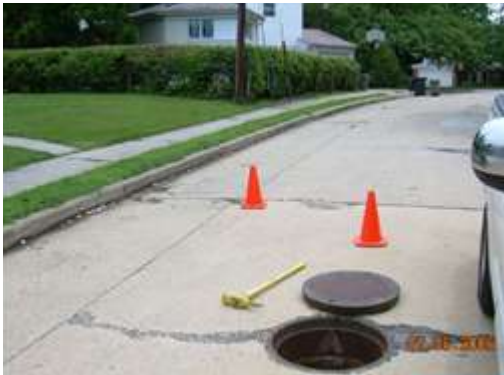
Location View

Comments **Cracks in pavement around manhole. Possible source of infiltration.**

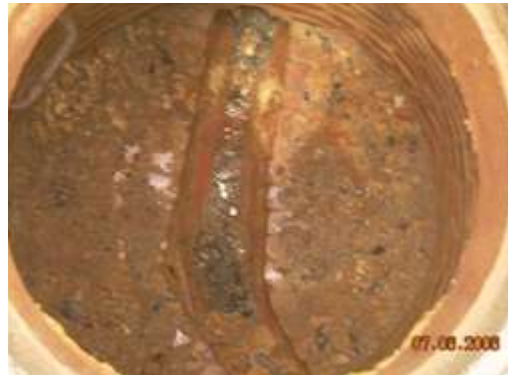
Top View

Evidence of surcharge - Bench debris.
Channel debris.

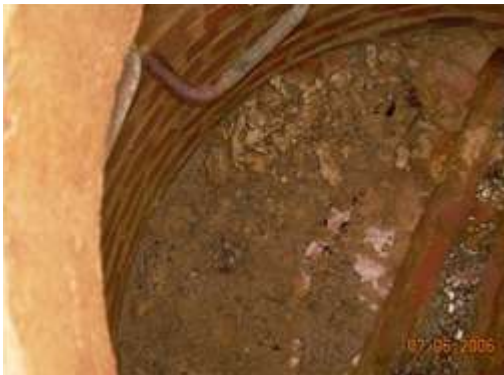
Defect

Frame leaks. Adjustment infiltration.
Corroded steps.

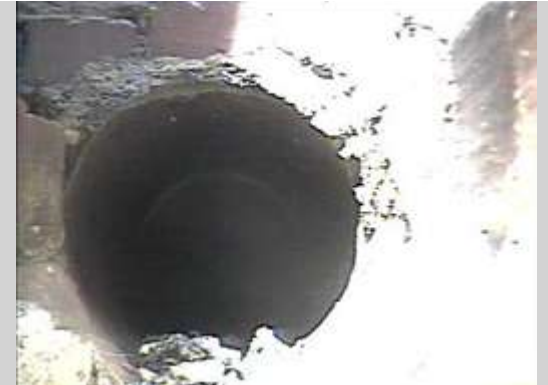
8 in. Circular Gravity Sewer Pipe Out @ 12 O'Clock

Deposits: ☐ None ☐ Mud ☐ Sludge ☒ **Debris** ☐ Grease

Silt Depth: **0.5** (in.) Deposits Extent: **Light**

Infiltration: **Evidence** Pipe Seal Cond: **Unknown**

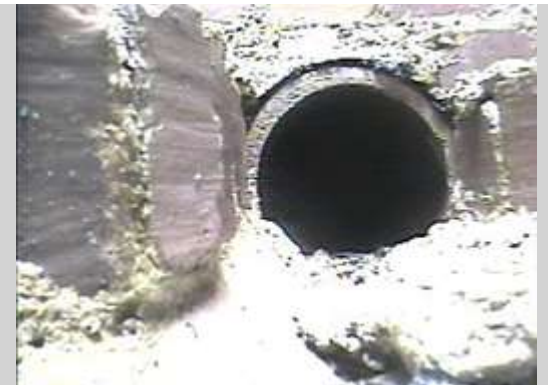
6 in. Circular Gravity Sewer Pipe In @ 5 O'Clock

Channel and pipe debris

Deposits: ☐ None ☐ Mud ☐ Sludge ☒ **Debris** ☐ Grease

Silt Depth: **0.5** (in.) Deposits Extent: **Light**

Infiltration: **Evidence** Pipe Seal Cond: **Unknown**
